Aircraft Manufacturing & Design LLC  
Heart of Georgia Regional Airport  
441 Airport Road, Eastman Georgia 31023 USA  
[www.newplane.com](http://www.newplane.com)  
TEL: (478) 374-2-SKY FAX:(478) 374-2793

## NOTIFICATION

Securing control surfaces when aircraft is parked

All AMD models

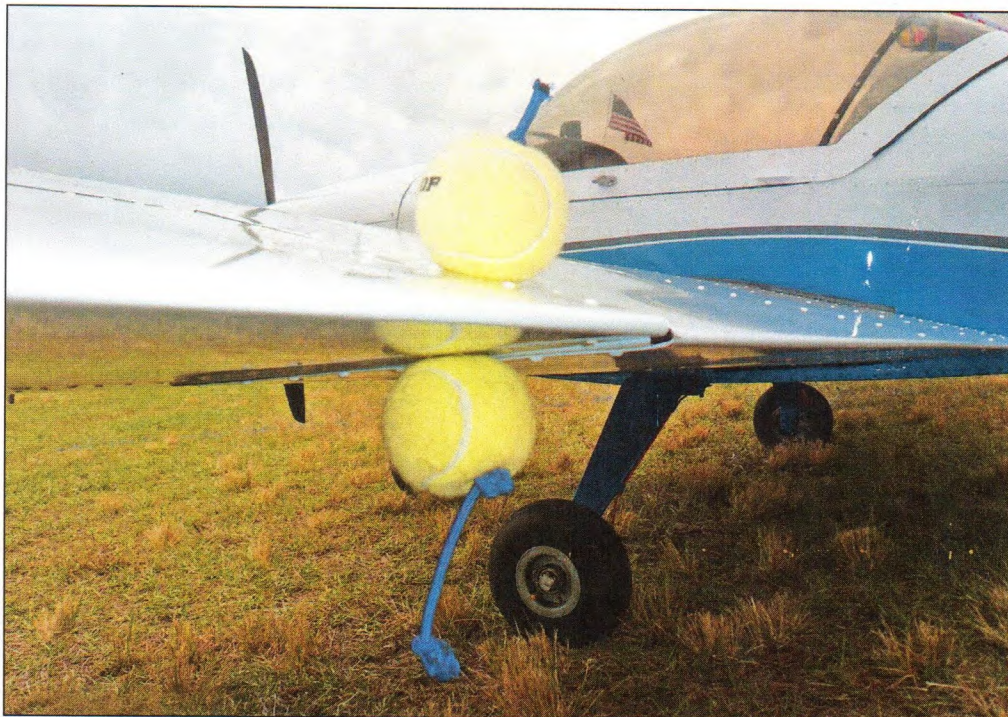
Above: Aileron control lock made from two tennis balls and a bungee cord.

Control locks are highly recommended to prevent damage while the aircraft is on the ground. Below are a couple pictures of simple control locks that can easily be made at home from a couple tennis balls or plywood and some bungee cord.

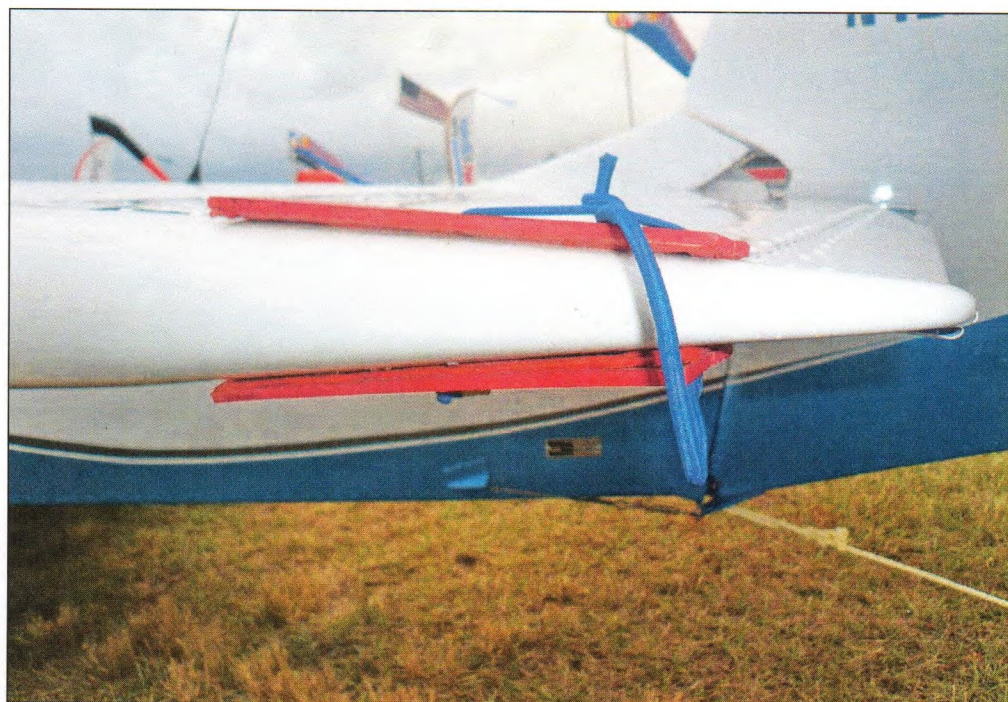
Above: Elevator control lock made from two pieces of plywood and a bungee cord.
